Technical Report REMR-CS-46  
March 1995

## **Repair and Maintenance of Masonry Structures: Case Histories**

*by Edward F. O'Neil*

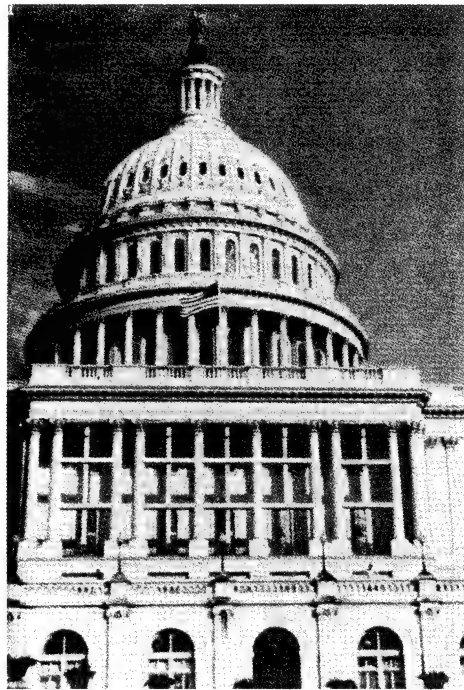
The AOC had known for many years that the West Facade of the Capitol was in need of repairs. For 2 decades the colonnade on the West Front of the building had been braced by huge timber trusses, Figure 2, to prevent the weakened structure from collapsing. The sandstone veneer of the facade was crumbling from deterioration largely due to freezing and thawing of a relatively weak porous material and age and falling pieces could be dangerous.

Figure 2. View of West Facade Colonnade showing supporting timbers

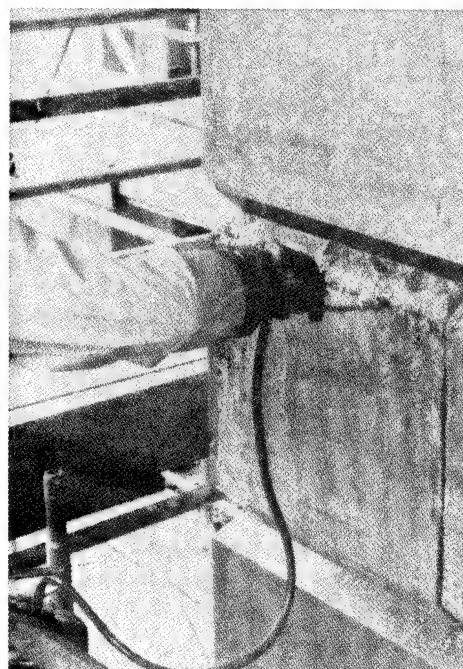
Figure 5. Application of stone strengthener to sandstone

Before the coating was begun, the stone was cleaned to ensure that no loose material was left on the surface. The coating material could be applied by brush, roller, or airless spray but was applied by the latter method because of all the detail in the carvings of the stone. Since it was to be sprayed on, it was diluted with up to 15 percent fresh water to thin it for even application through the spray nozzle.

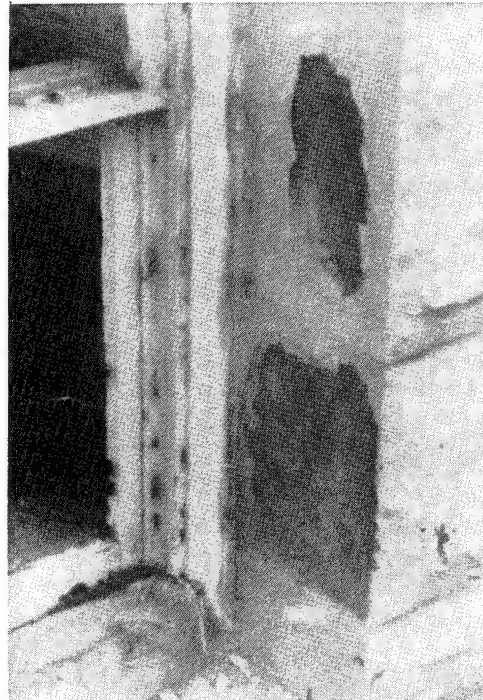
Figure 8. View of wall showing spalling damage to sandstone

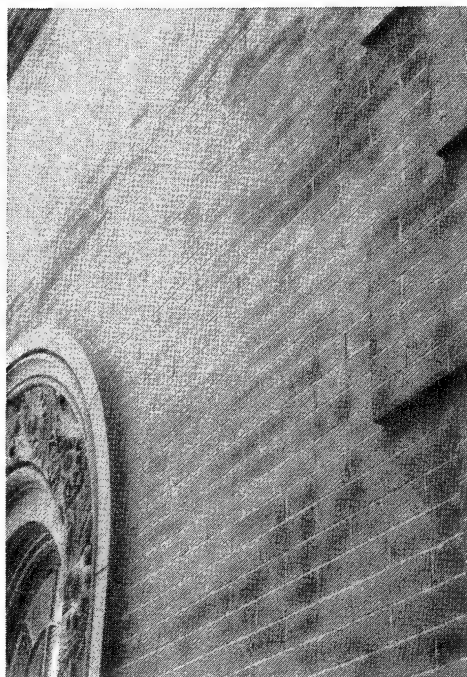
Figure 9. View of brick showing nozzle damage

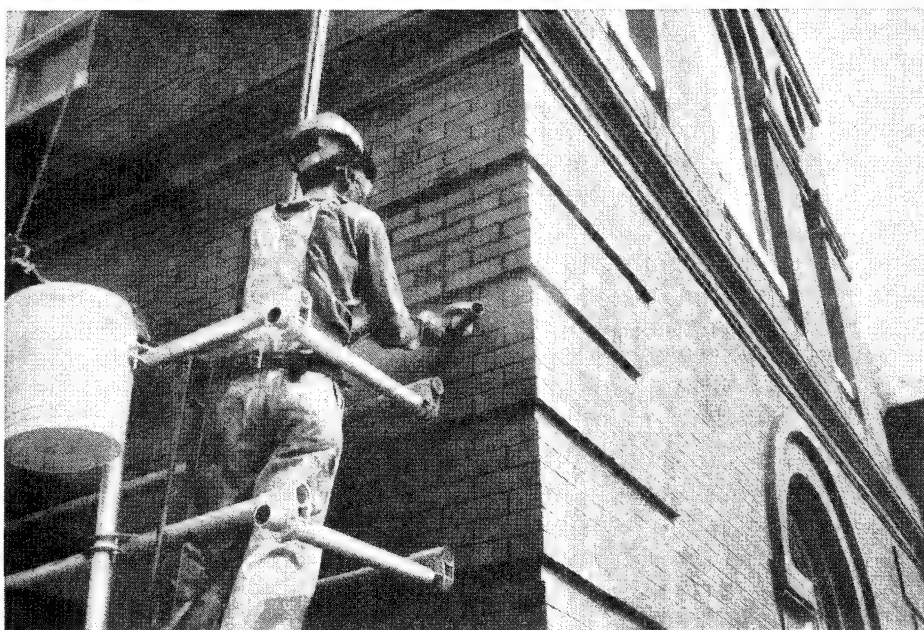
Figure 10. Worker routing bricks with small saw

The mortar used for the repointing was composed of 4 parts lime, 1 part portland cement, and 12 to 14 parts sand. This mixture was submitted and approved by the architect. The use of lime as binder in repointing mortar is encouraged because it produces a softer mortar than one made entirely from portland cement. Exactly matching a mortar to one that has been removed is not necessary (Mack, Tiller, and Askins 1980). The important points to remember about the replacement mortar are:

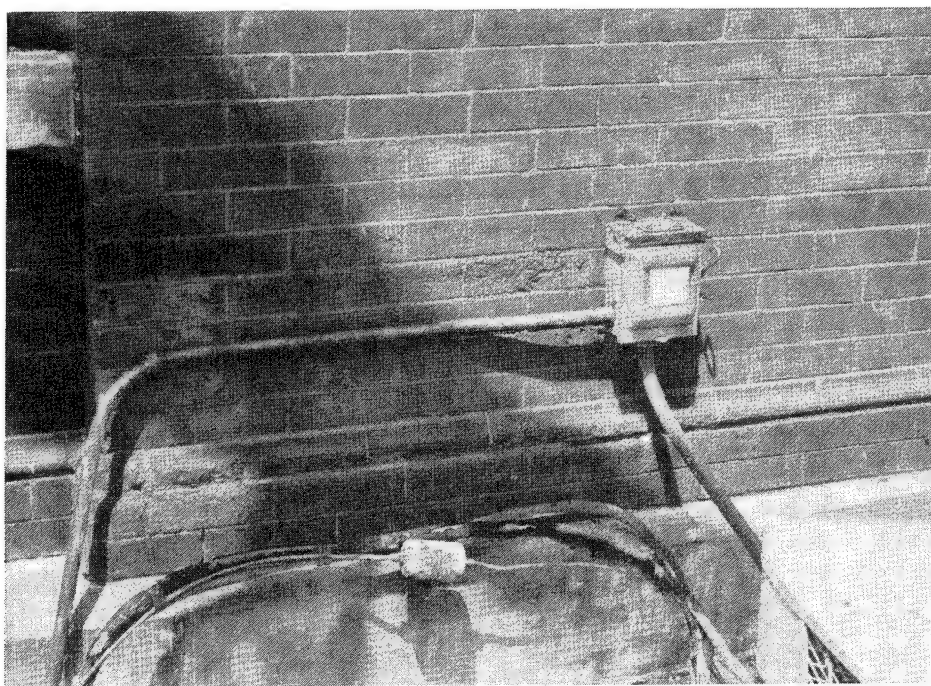
Figure 11. View of brick damage due to weathering

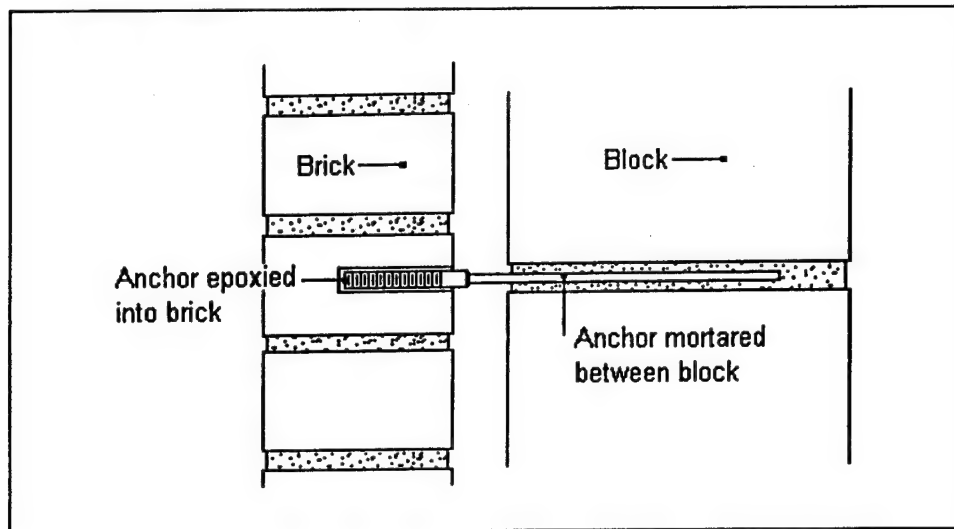
Figure 25. Sketch of anchor detail used to strengthen brick walls

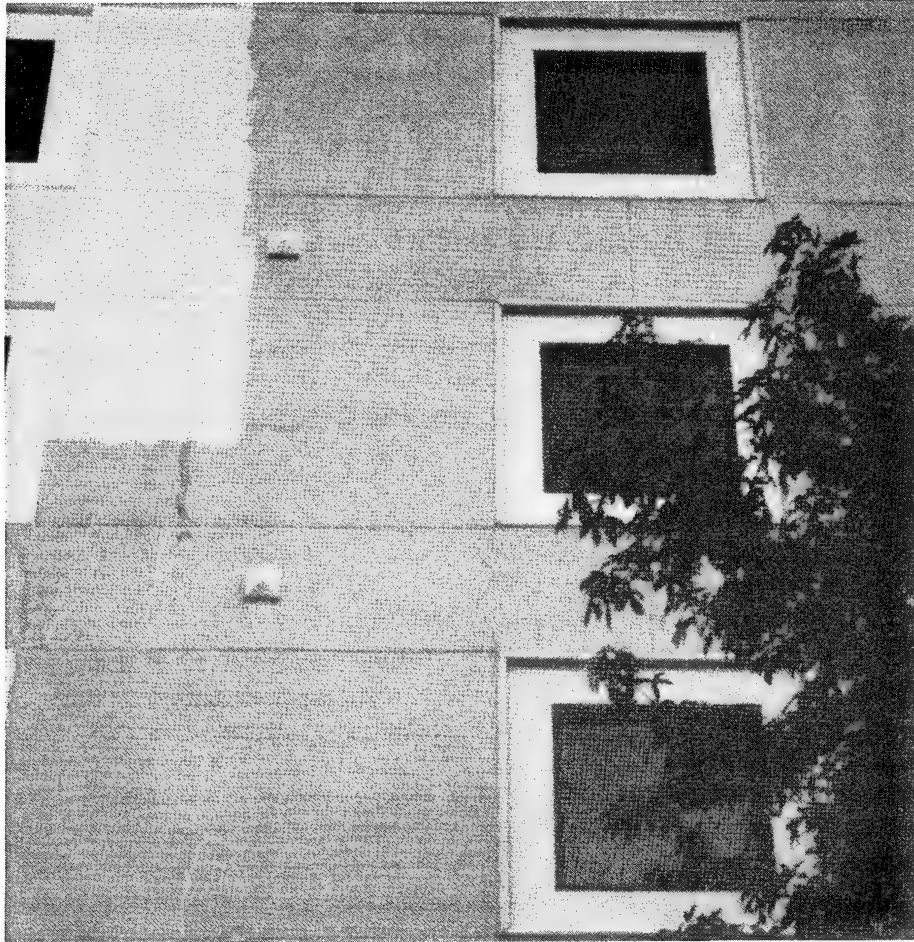
The engineering firm that was hired to evaluate the structure and provide a solution noted that much of the cracking was a function of problems with building expansion. There were expansion cracks and movement cracks on panels on all sides of the building. They found that the building had been built without planning for expansion joints between panels. Therefore, when

Figure 28. Vertical cracks in panels at left of window

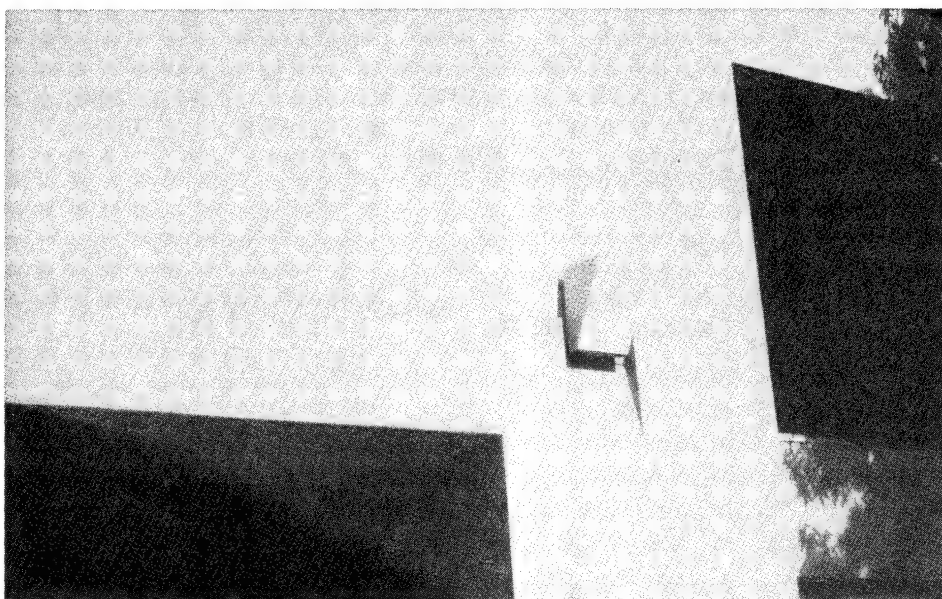
Figure 29. Cracking in panel at a corner

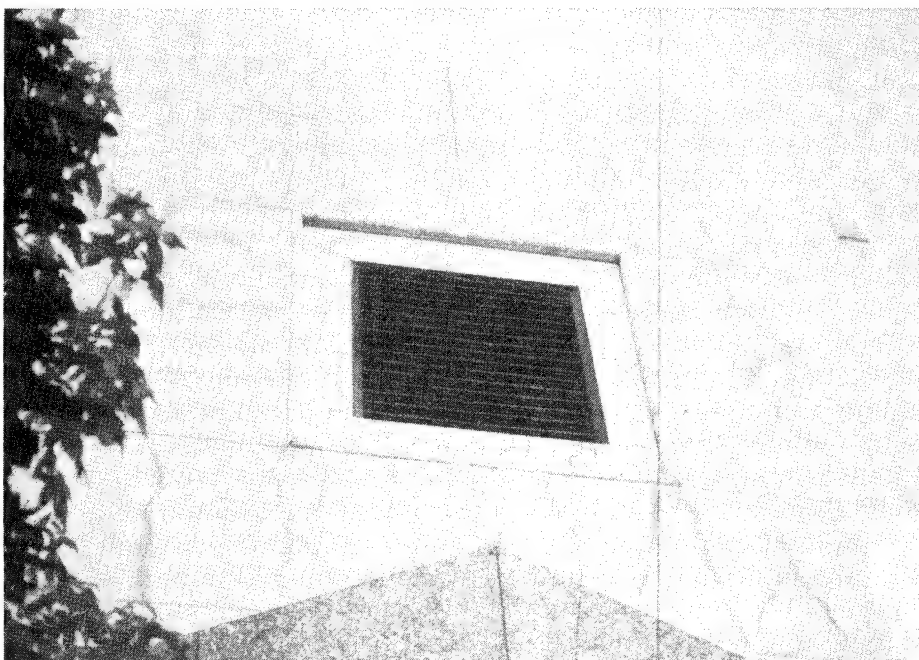
Figure 30. Shrinkage cracking in panels

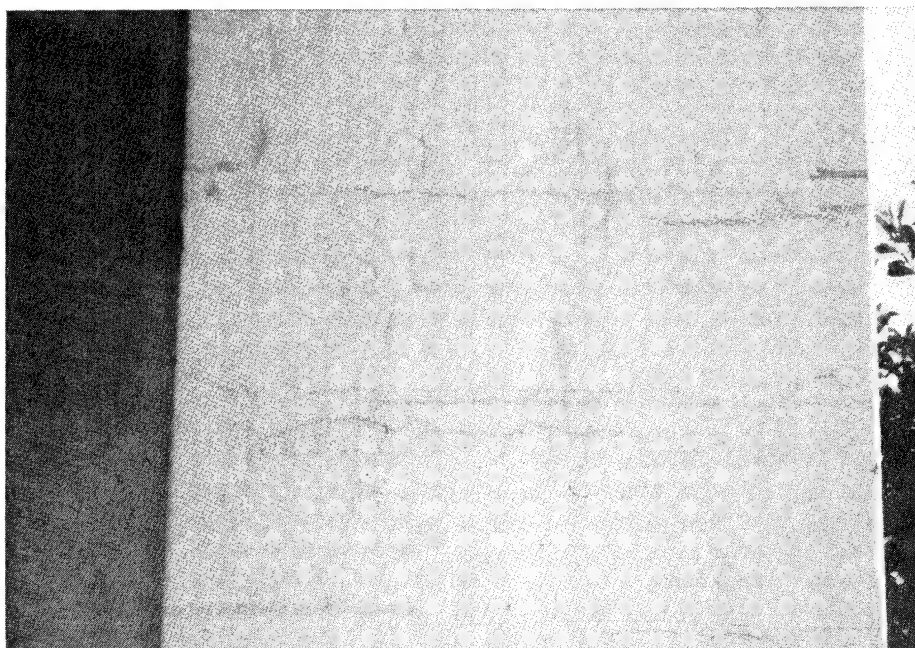
Figure 31. Cracked column panel showing smooth panel coating

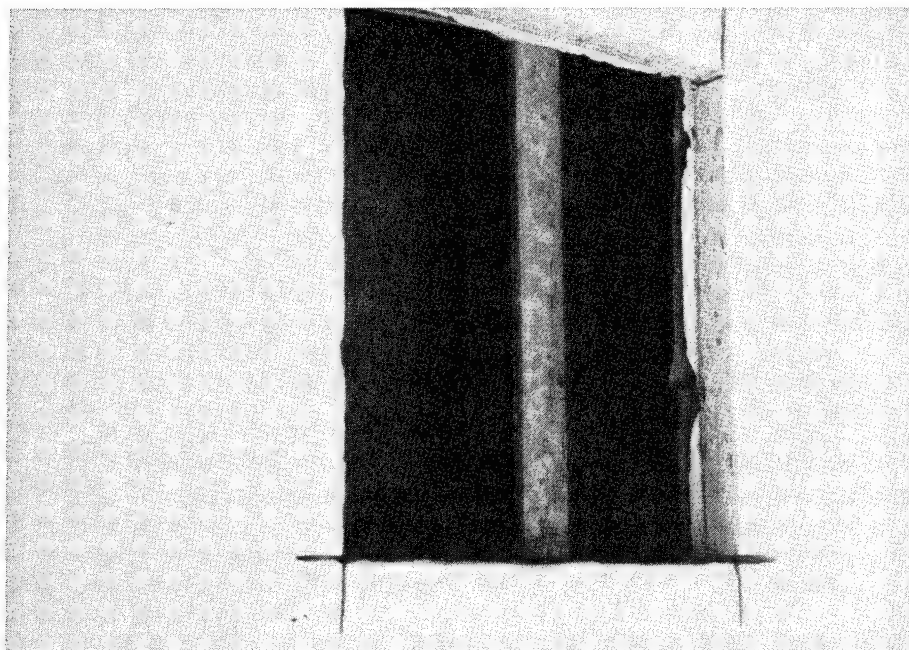
Figure 32. Smooth elastomeric coating applied on column panel

The method of applying the different elastomeric acrylic coatings depended upon the type of surface texture that was desired. In those areas where the coating was to be smooth and to be applied over an old smooth surface, the coating used was a high-flexibility, acrylic-polymer coating that was tinted to match the color of the building. The old smooth surface had been cleaned and all loose paint removed by the power washing. The smooth coating was then rolled on with conventional paint rollers and supplemented in difficult-to-reach areas by brush application. The first coat was allowed to dry for a period ranging from between 1 to 4 hr, depending upon ambient drying conditions. The first coat was followed by a second coat once the first had dried. Figure 32 shows this type of coating on one of the column panels. This provided a water-resistant, vapor permeable elastomeric coating.

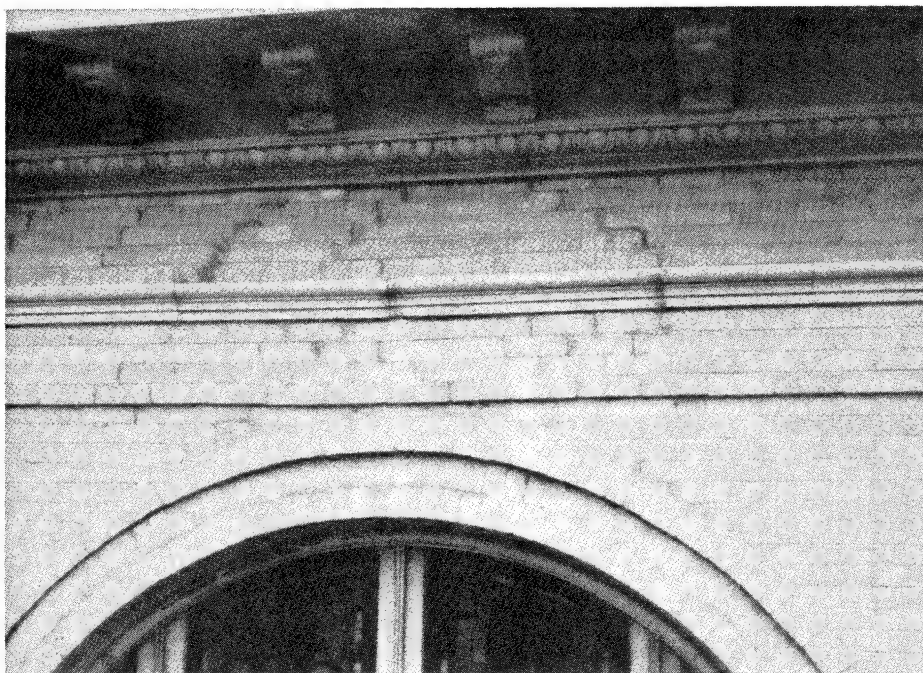
This case study is not only a restoration study, but also a structural study. The original reason for the restoration was to alleviate a problem of cracking in the east and west walls of the central chapel. Cracks in ceiling plaster over one of the wing chapels was the first reason to conduct a survey of the entire building. The building survey showed up a number of other cracks in the walls and the brickwork on the outside of the building. The major cracks were apparent in the east and west walls of the central chapel over the center of the most northern arch windows (Figure 39). The cracks were narrow at their base and became wider as they progressed up the wall. Some of the widest cracks could not be seen from within the chapel itself and had to be viewed from above the inside ceiling of the central dome. These cracks were on the order of inches wide and penetrated completely through the thickness of the wall. This led engineers to suspect that there was differential settlement of the building and that the front and back portions of the building were settling in different directions. A survey of elevations of the building was conducted and it was determined that the south face of the building had settled over 4 in. in relation to the north face.

Figure 39. Cracks over arch window in west facade

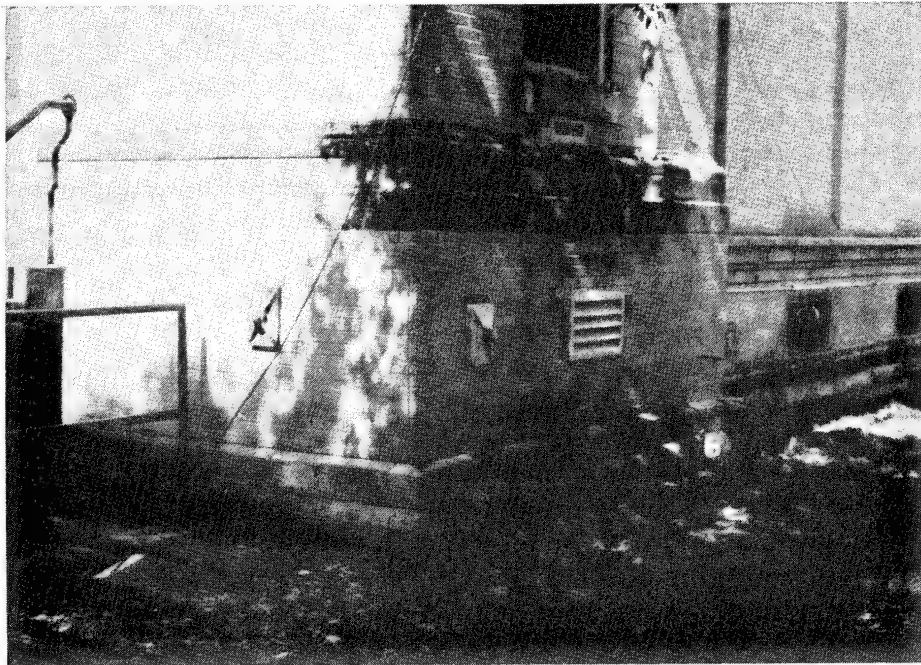
east-west direction (Figure 40). These had been in place from previous repairs. The tie rods that were to be installed during this renovation were to run north and south to address the separation of the building in this direction.

Figure 40. Existing tie-rod anchor in east facade at northeast corner

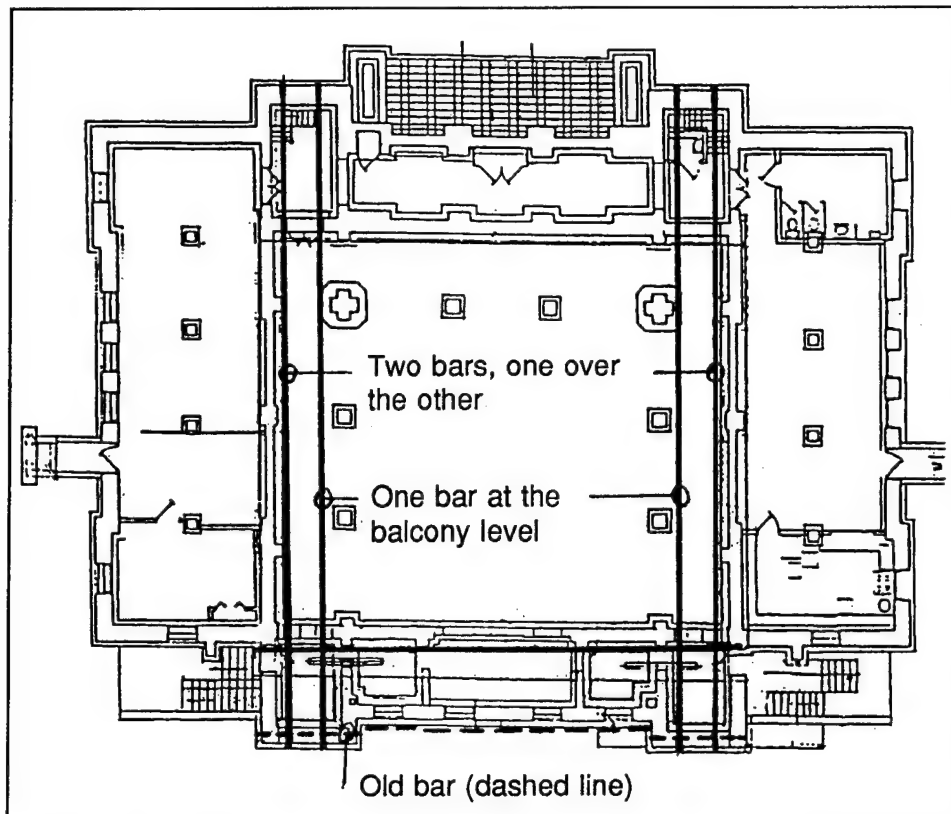
Figure 41. Plan of gift chapel showing location of tie rods

The design of the tie rods was based on trying to compensate for an overturning moment on the wall due to a 2-in. out-of-plumb condition of the north wall. The overturning moments due to the weight of the brick wall, the dead load of the roof bearing on the wall, and the live load of the roof bearing on the wall were summed and equated against a righting moment (one tie rod) at a height of 34 ft above the base of the wall. The tie rod and bearing plate were designed from the resulting force in the tie rod. Six such tie rods were

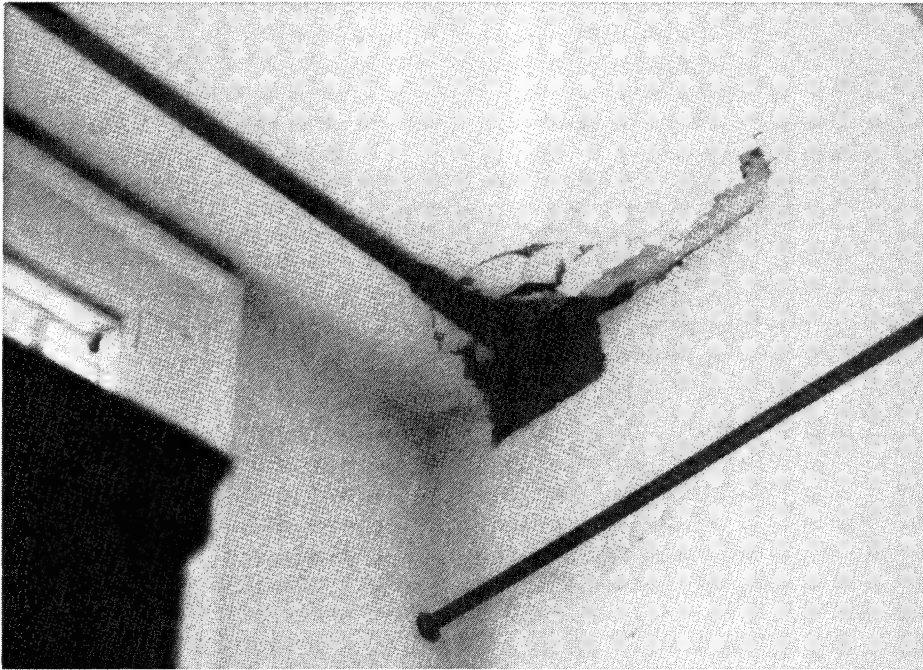
Figure 42. Two tie rods in the northeast corner of the chapel

In choosing the location of the rods, the engineering team gave much consideration to visibility, safety, and proper location. Consideration was given to routing the rods within the walls and inside the woodwork that runs around the balcony of the central chapel. However, the effort to accomplish such a feat was not economically feasible, and the rods were run adjacent to walls. Their final location was chosen so that their visibility would be limited. They were run near the floor, behind pews, and in corners between

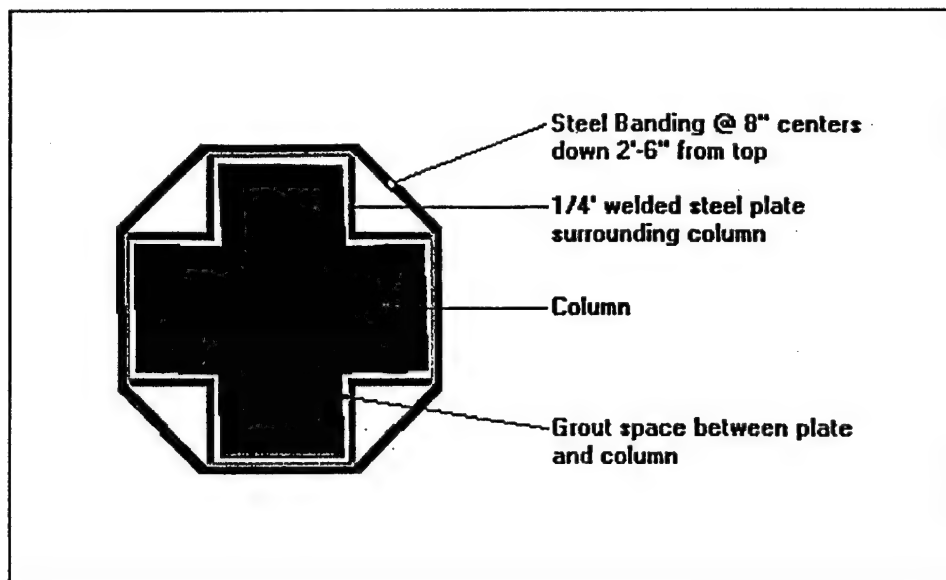
Figure 43. Sketch of repairs to the damaged columns

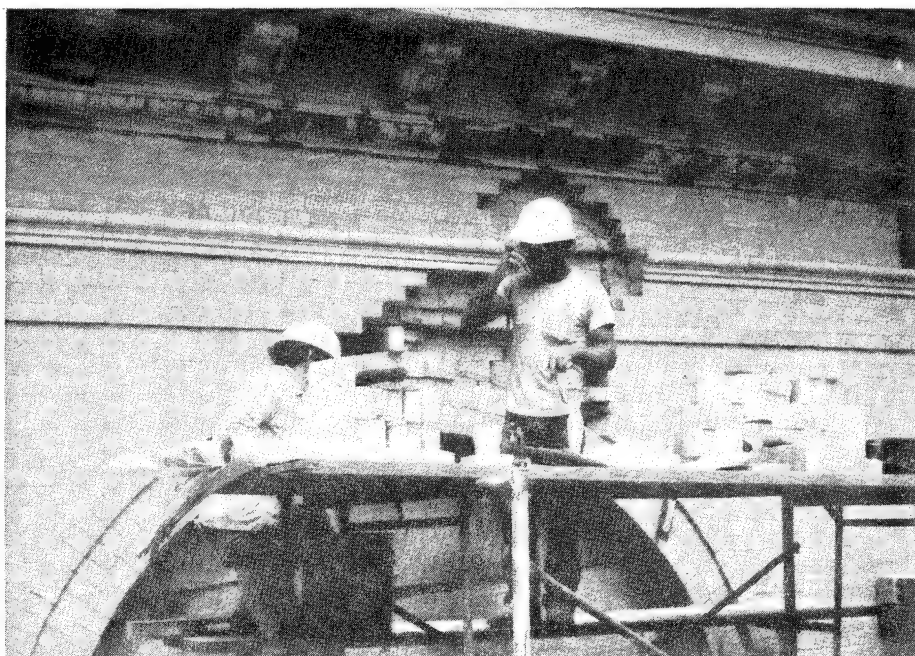
Figure 44. Rebuilding of arch window at northeast corner of central chapel

An arch-shaped form was built to use as a guide in replacing the bricks in the new arch. The masons reused any bricks that were not damaged during the dismantling of the wall. In instances where there was need for more bricks, they drew from a supply of bricks which they reclaimed when dismantling a brick chimney from the north facade of the chapel.

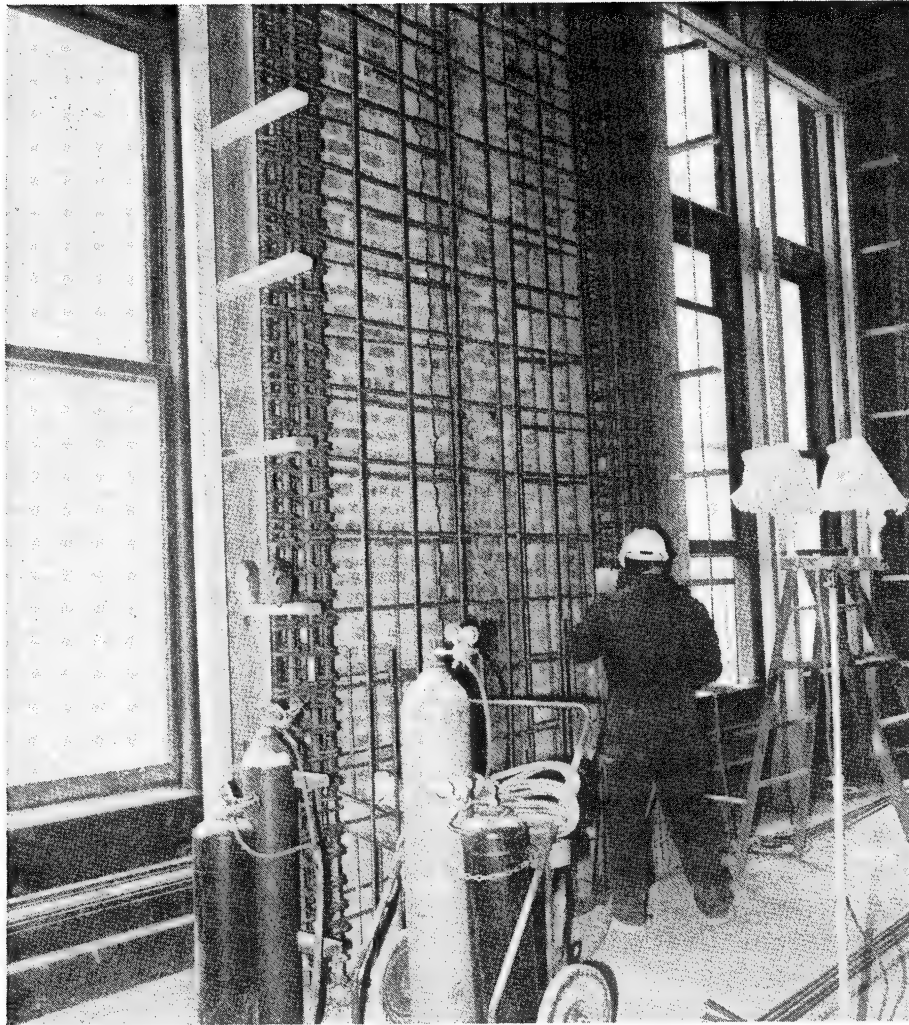
**Figure 52.** Strengthening of walls behind historical facades
